NPS-AM-11-008

Mark XIV Torpedo Case Study

David F. Matthews, Senior Lecturer

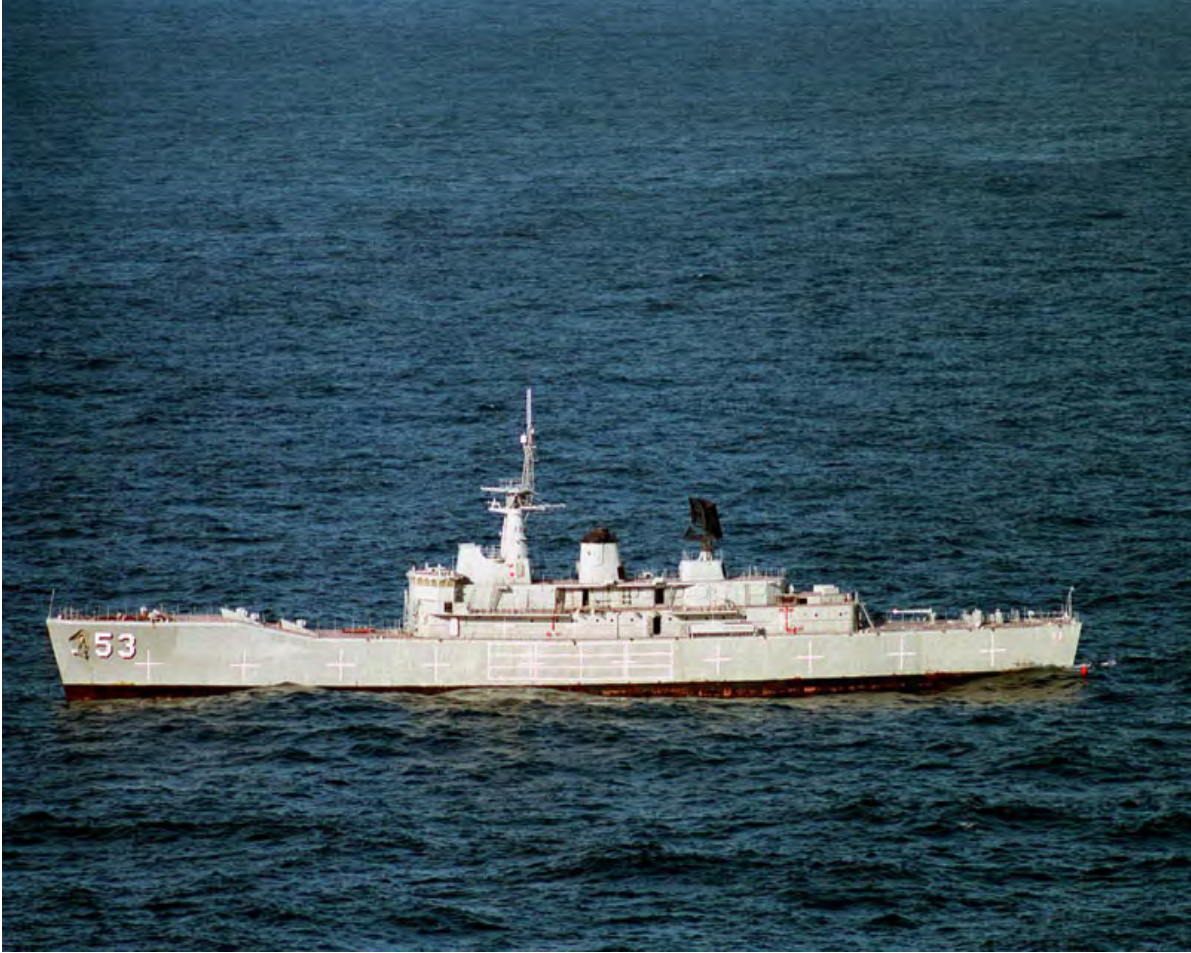
Figure 2. Destroyer Prior to Detonation
(Navy Undersea Warfare Center, 1999)

Figure 2 is a picture of the obsolete full-sized Australian destroyer that served as the test target. Everything useful was removed from the destroyer—all turrets, depth charges, secondary armament, etc. The configuration is visible in subsequent photos. Figure 2 shows the target ship sitting dead in the water waiting to be engaged.

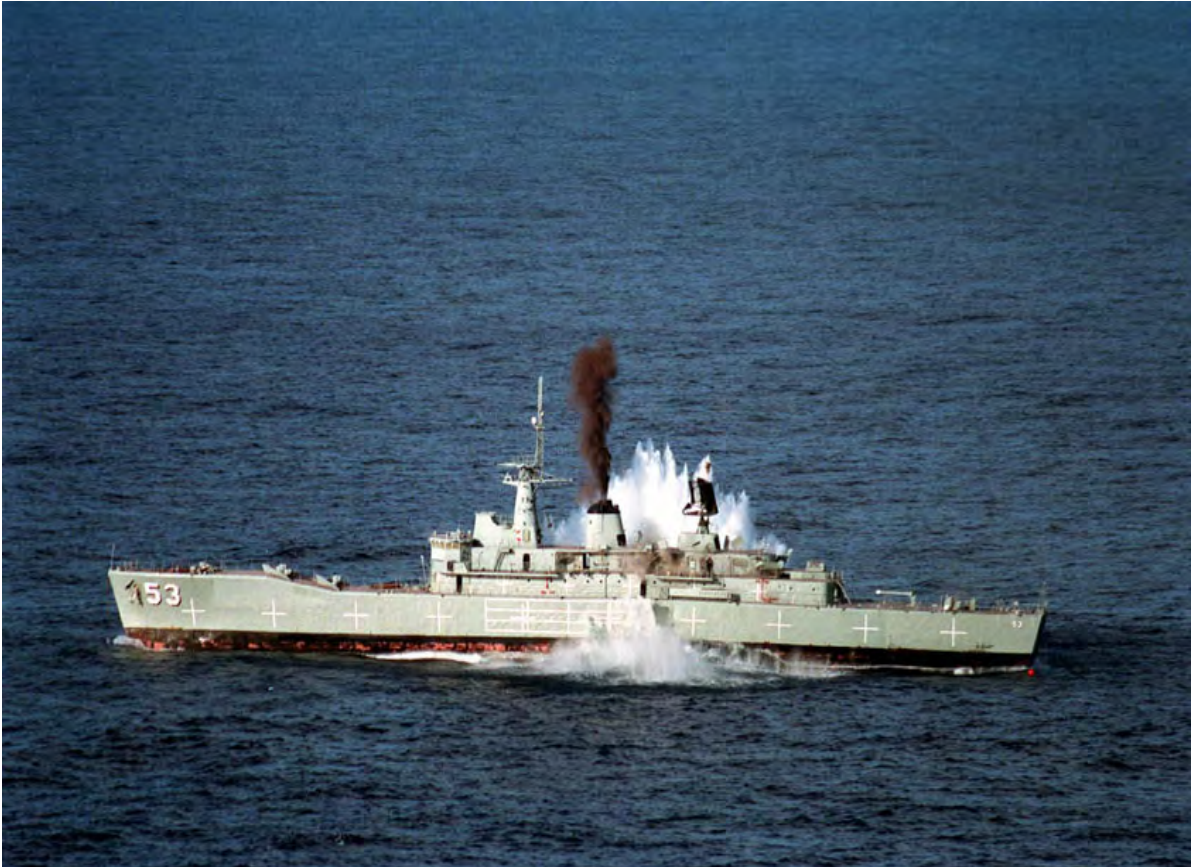
Figure 3. Initial Reaction
(Navy Undersea Warfare Center, 1999)

Figure 3 is a photograph of the moment the torpedo was detonated. The photograph shows that smoke has been blown out of the stack because of the power of the explosion, and it shows that water is starting to erupt on either side of the ship. In Figure 3, the ship already appears to have had its keel broken because the bow and the stern are lower than the center of the ship.

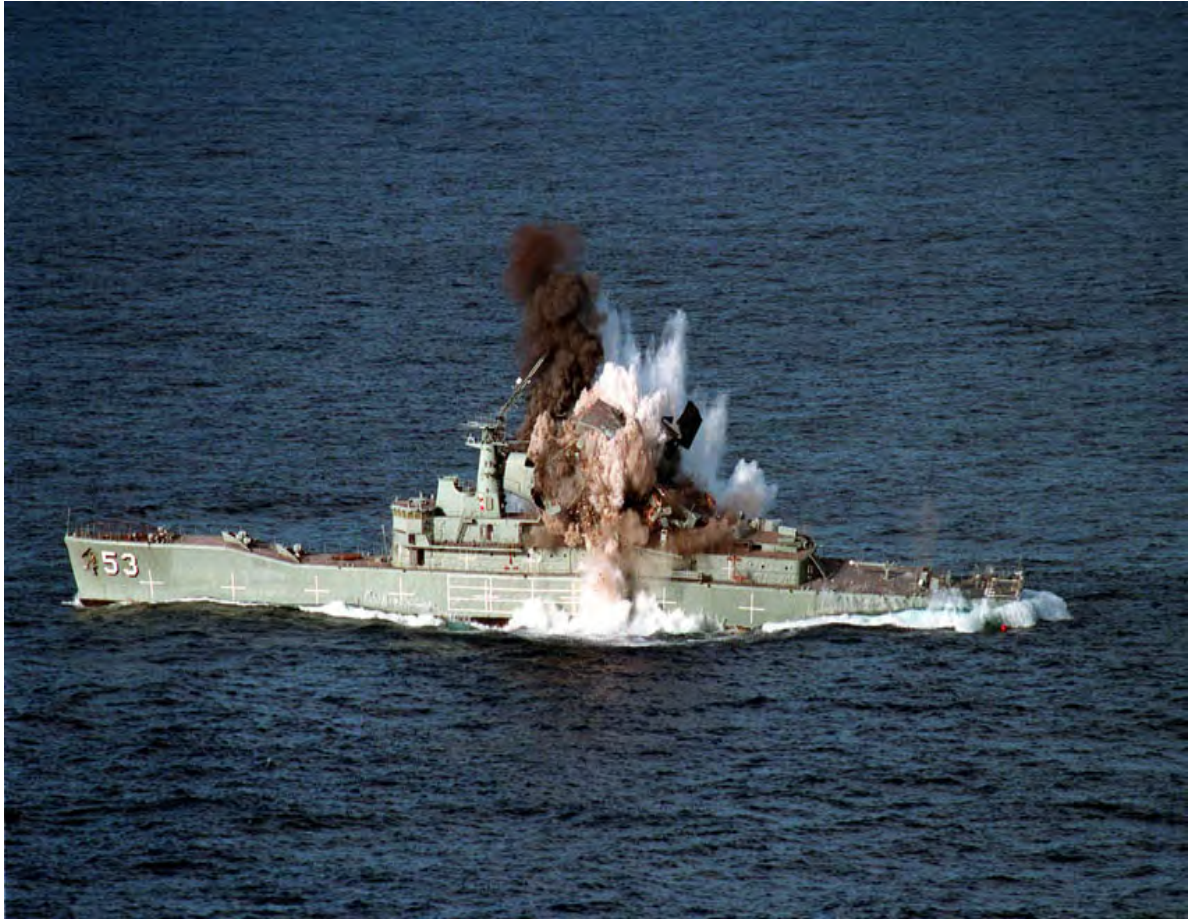
Figure 4. Further Damage
(Navy Undersea Warfare Center, 1999)

Figure 4 is a photograph of a few seconds, maybe even milliseconds, later. The explosion has propagated even further, and the power of the torpedo warhead's explosive is visible as it goes straight up through the bowels of the ship along the center line—and it only gets worse.

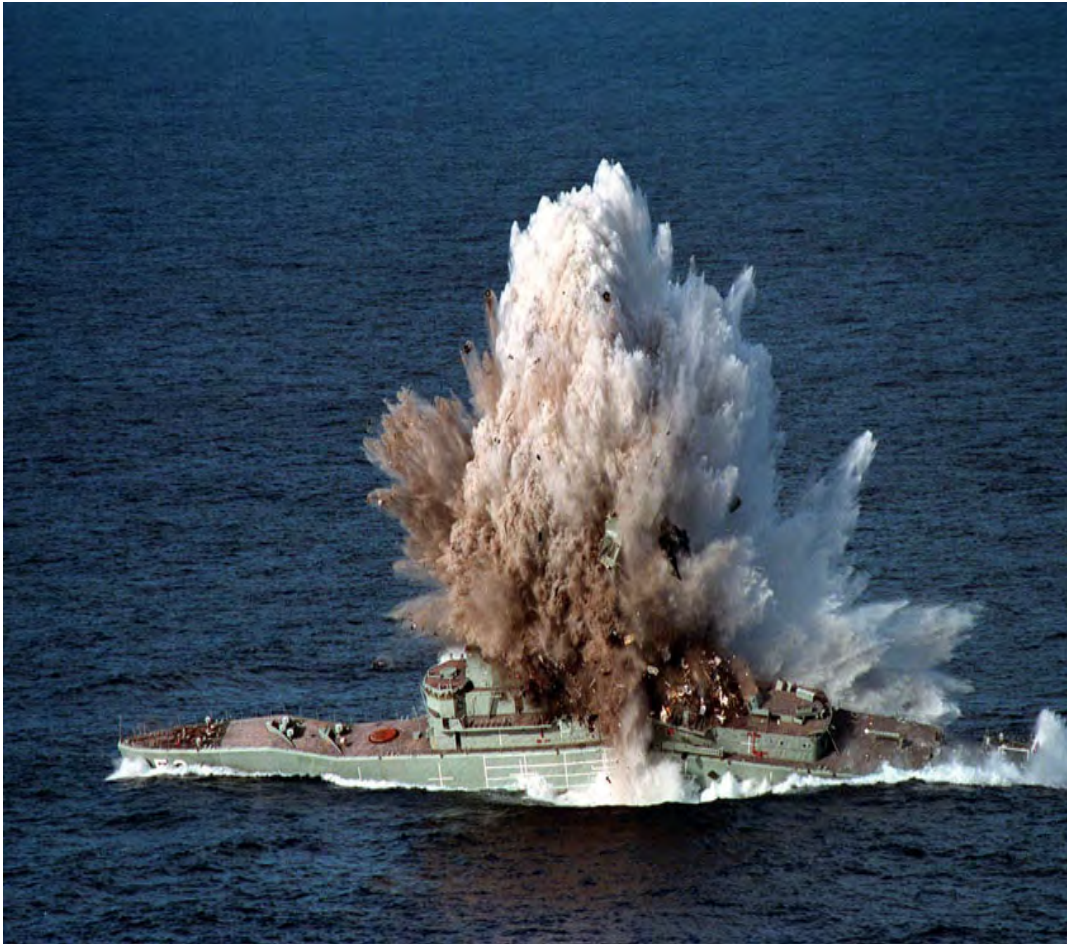
Figure 5. The Keel Has Broken
(Navy Undersea Warfare Center, 1999)

Figure 5 clearly shows that the back of the destroyer has been broken. The extensive level of damage that is taking place is obvious.

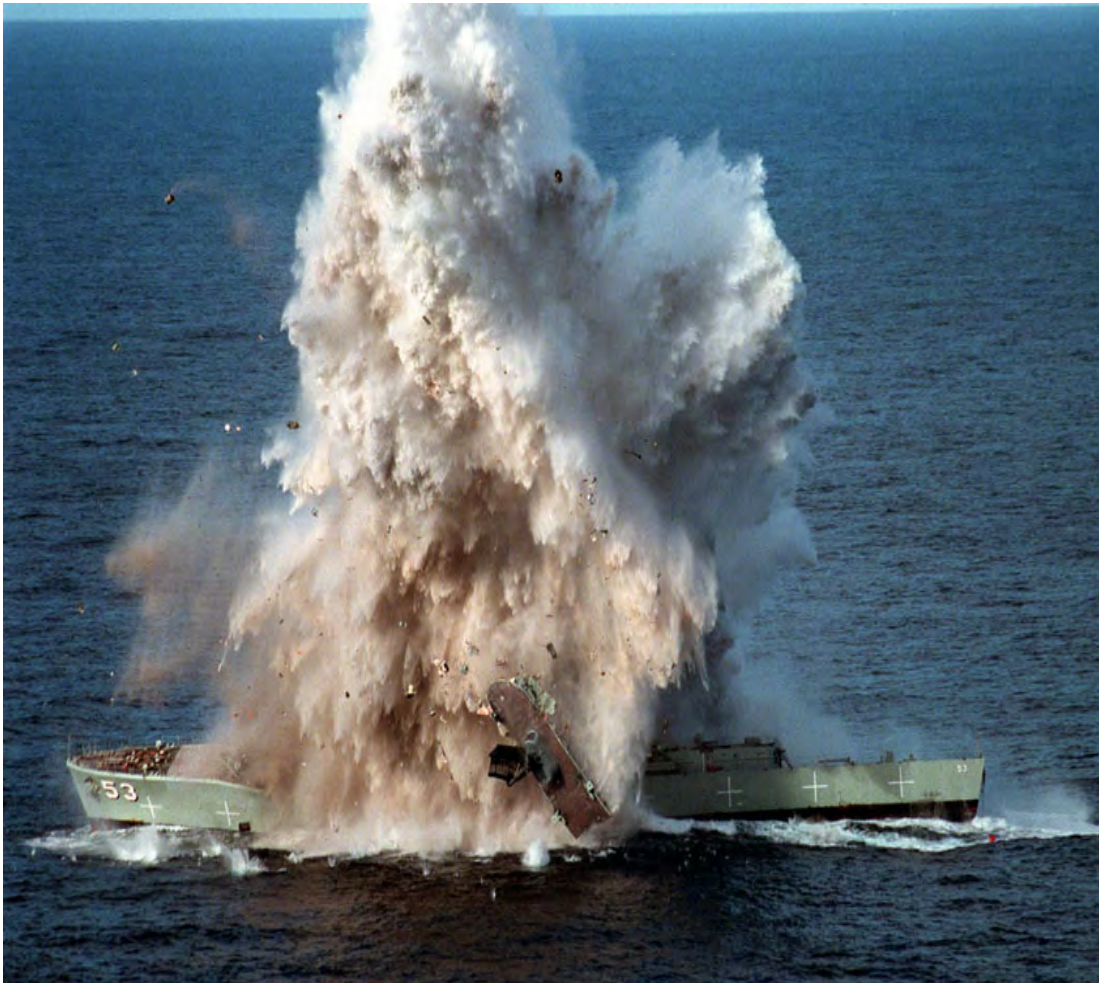
Figure 6. Bow and Stern Sections Separate
(Navy Undersea Warfare Center, 1999)

Figure 6 shows that the level of damage is now catastrophic.

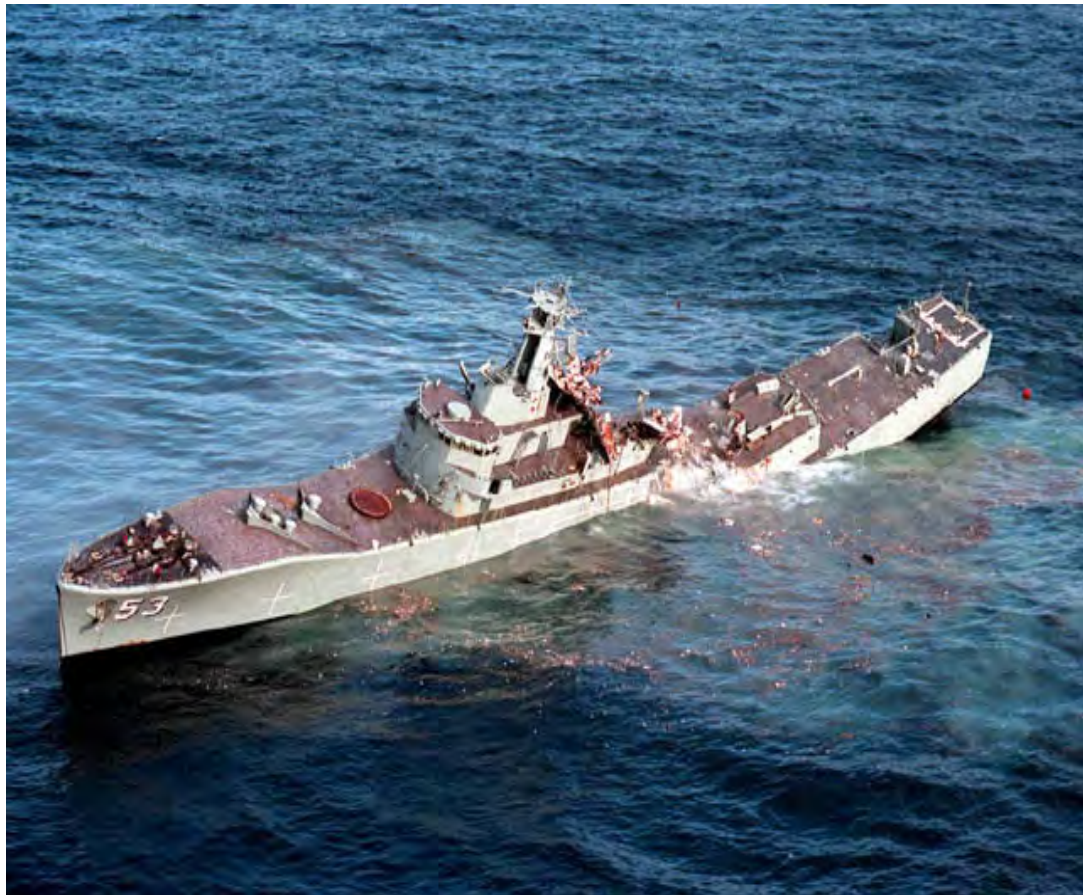
Figure 7. The Stern Begins to Sink
(Navy Undersea Warfare Center, 1999)

As the smoke clears in the photograph in Figure 7, it is clear that the destroyer has broken into two halves and that the stern section is about to sink.

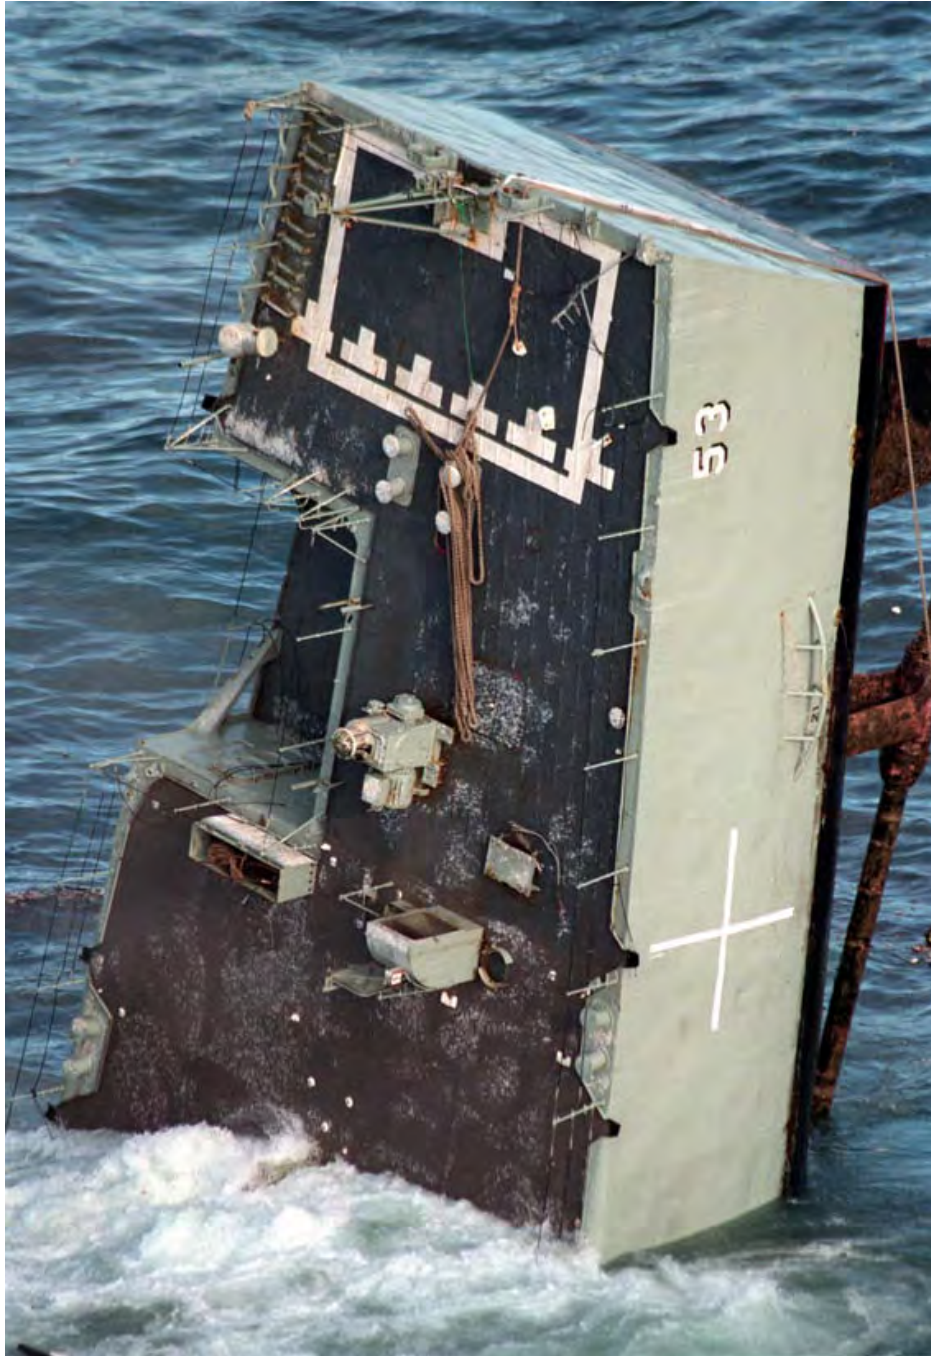
Figure 8. The Stern Slips Under the Waves
(Navy Undersea Warfare Center, 1999)

Figure 8 shows that the observation made in Figure 7 is accurate: the stern section is headed to “Davey Jones’ Locker.” The photograph in Figure 8 is a close-up of the destroyer as it slips beneath the waves.

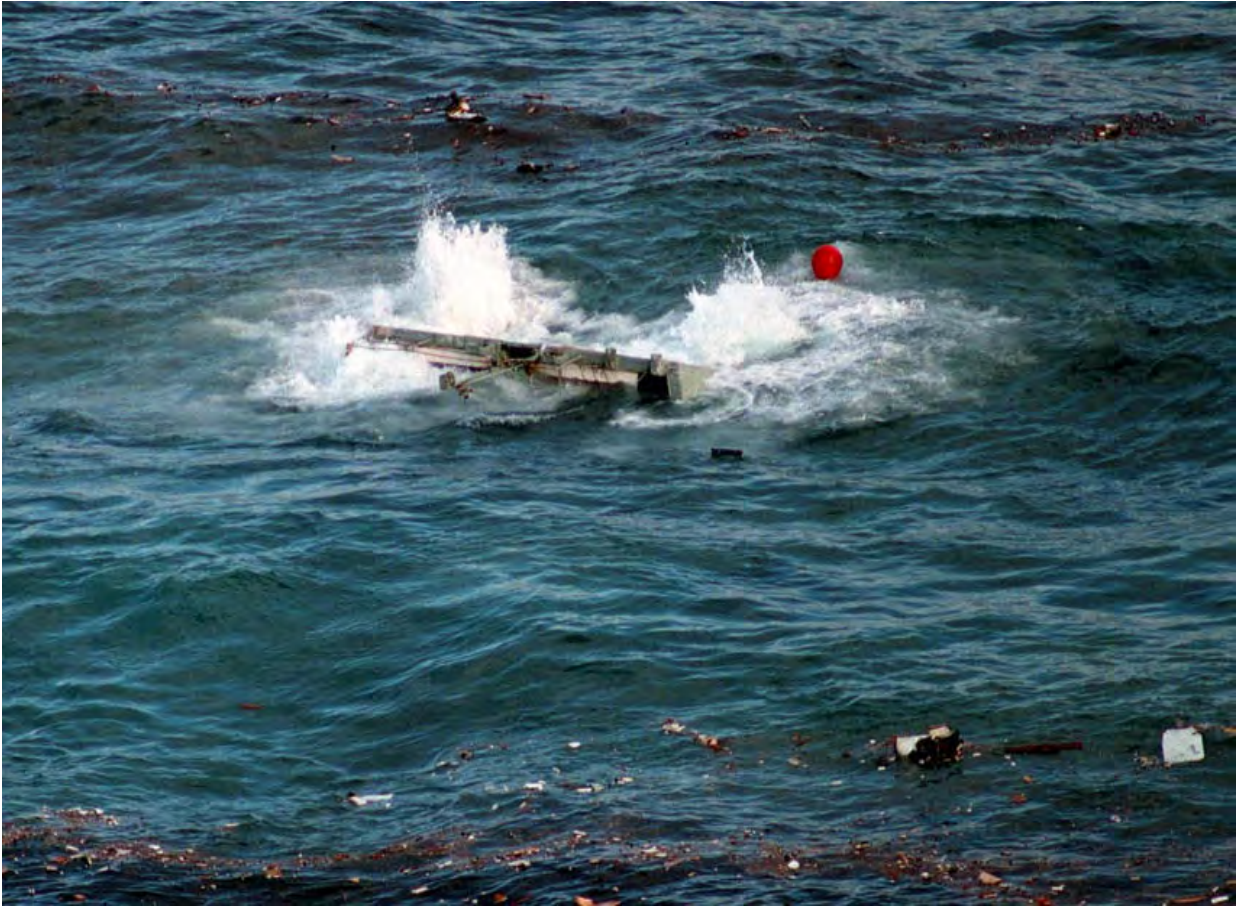
Figure 9. The Stern Disappears
(Navy Undersea Warfare Center, 1999)

Figure 9 is a close-up photograph of the residual debris field.

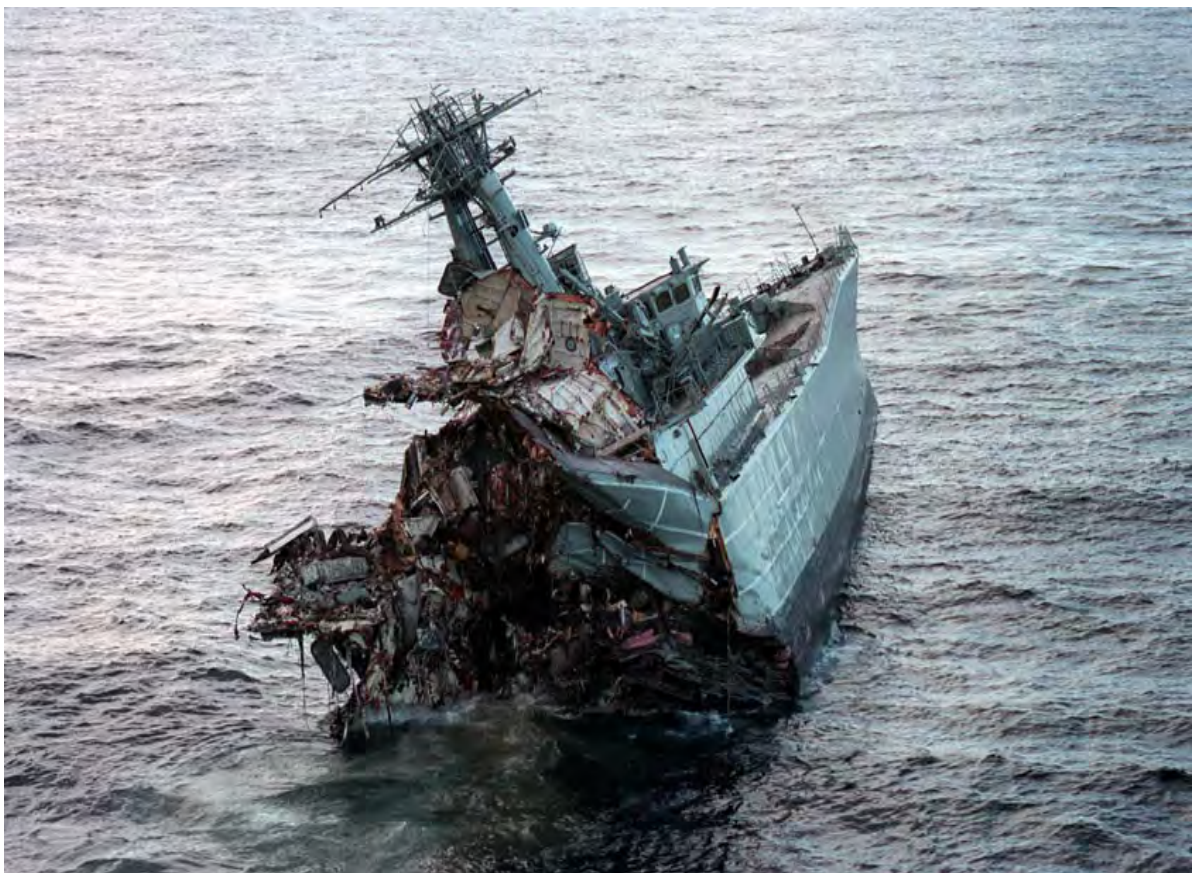
Figure 10. The Residual Bow Section
(Navy Undersea Warfare Center, 1999)

Figure 10 is a photograph of the bow section of the ship. As the photograph shows, it is not economically repairable. The damage is so bad that by the time the Australian Navy would have tried to salvage what is left there in order to rebuild a new ship around it, it would have been better to have started from scratch. Plus, ship designs evolve, and if this were an older ship, it would probably be better from a cost-effectiveness standpoint to acquire a “latest and greatest” warship of a similar class to replace this one. In this test, the bow section actually sank a few hours after the photograph in Figure 10 was taken.
